NASA Contractor Report 165634

Advanced Manufacturing Development of a Composite Empennage Component for L-1011 Aircraft

Phase II - Final Report Design and Analysis

Lockheed Corporation
Lockheed-California Company
Post Office Box 551
Burbank, California 91520

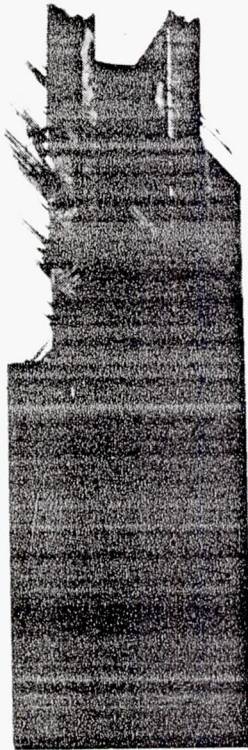
Figure 121. - H26B failed surface.

The panel was loaded to failure in tension, which occurred away from the joint, at 90 082 N (21,600 lb) or 143 percent design ultimate load. The failure was a combination tension failure (across the skin) and shear failure (between the hat and the skin). Figure 121 shows the failed surface after the residual test.
